DOCUMENT NO. D290-75303-2 Vol. III

TITLE IUS Program: Shock Analyses and Shock Tests

This volume of D290-75303-2 contains shock analysis and shock test results performed in support of the Inertial Upper Stage (IUS) program.

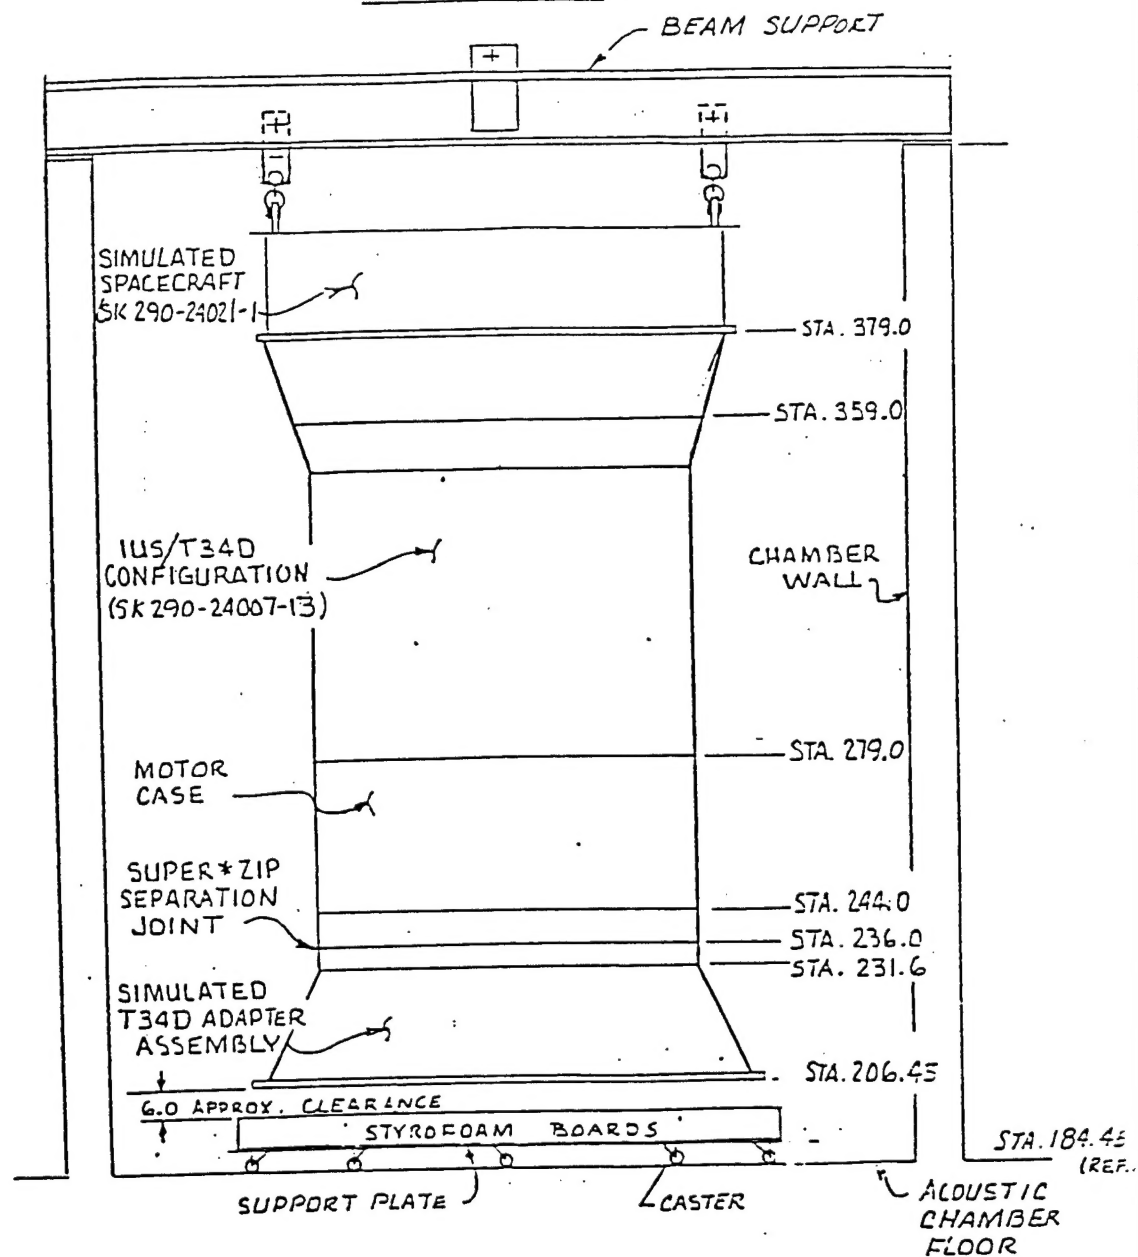
FIGURE 1

TEST SETUP - TITAN/IUS (T34D/DTV) SEPARATION SHOCK TEST

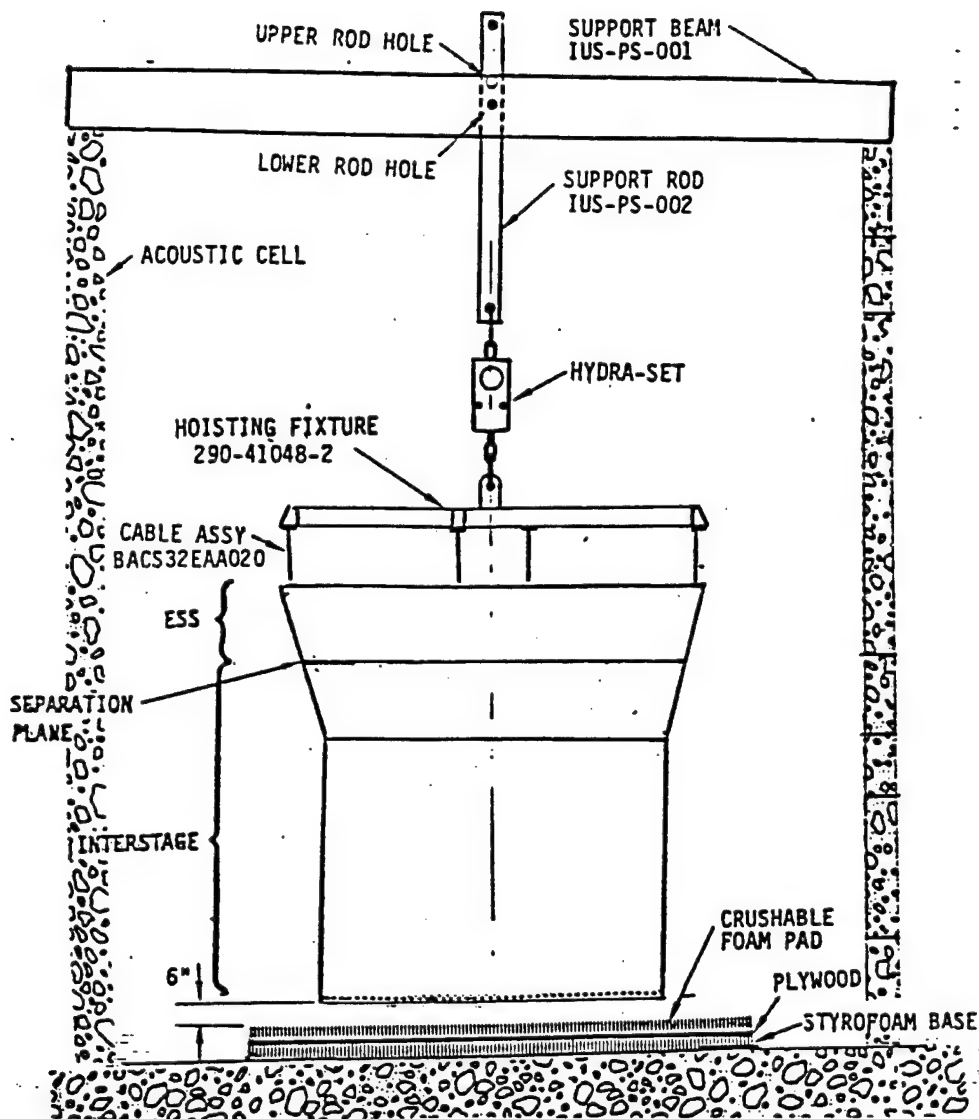
FIGURE 2-1 IUS QTV TEST CONFIGURATION

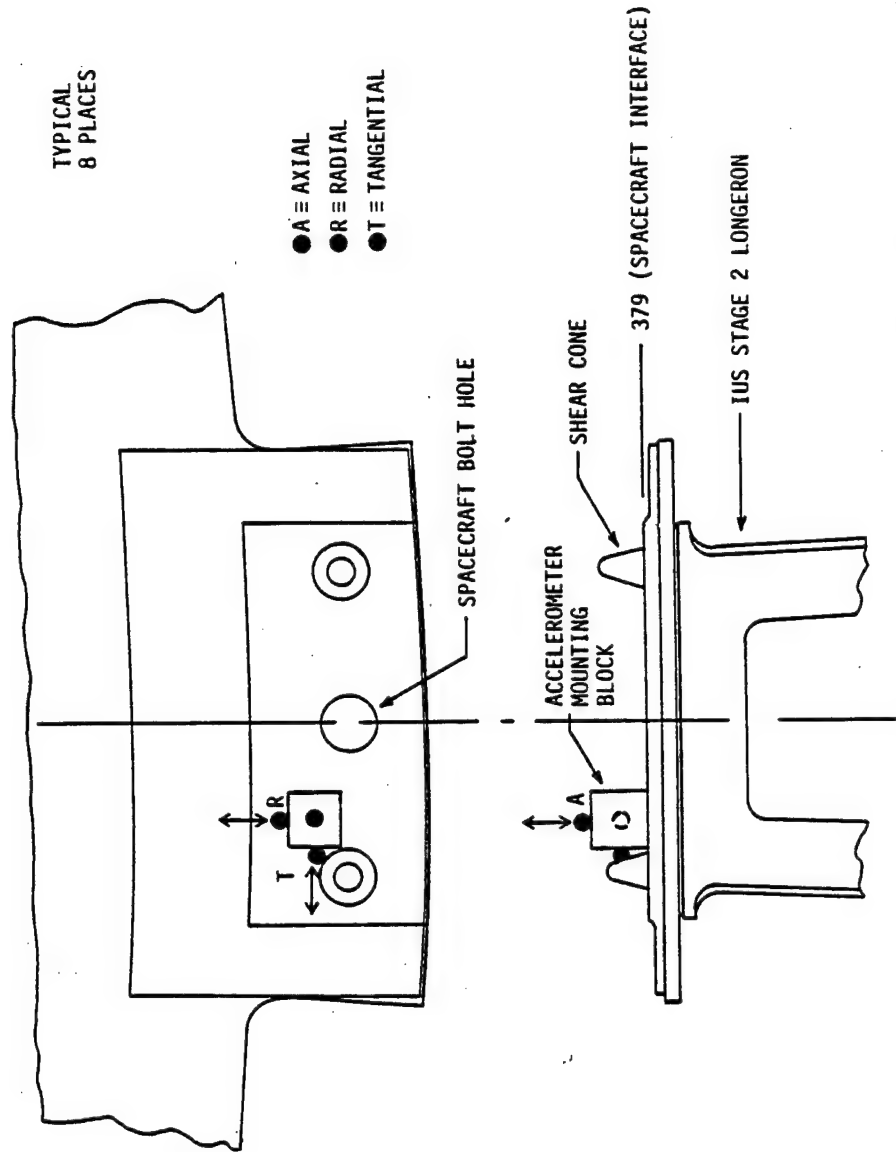
FIGURE 2-2 IUS QTV INTERFACE INSTRUMENTATION

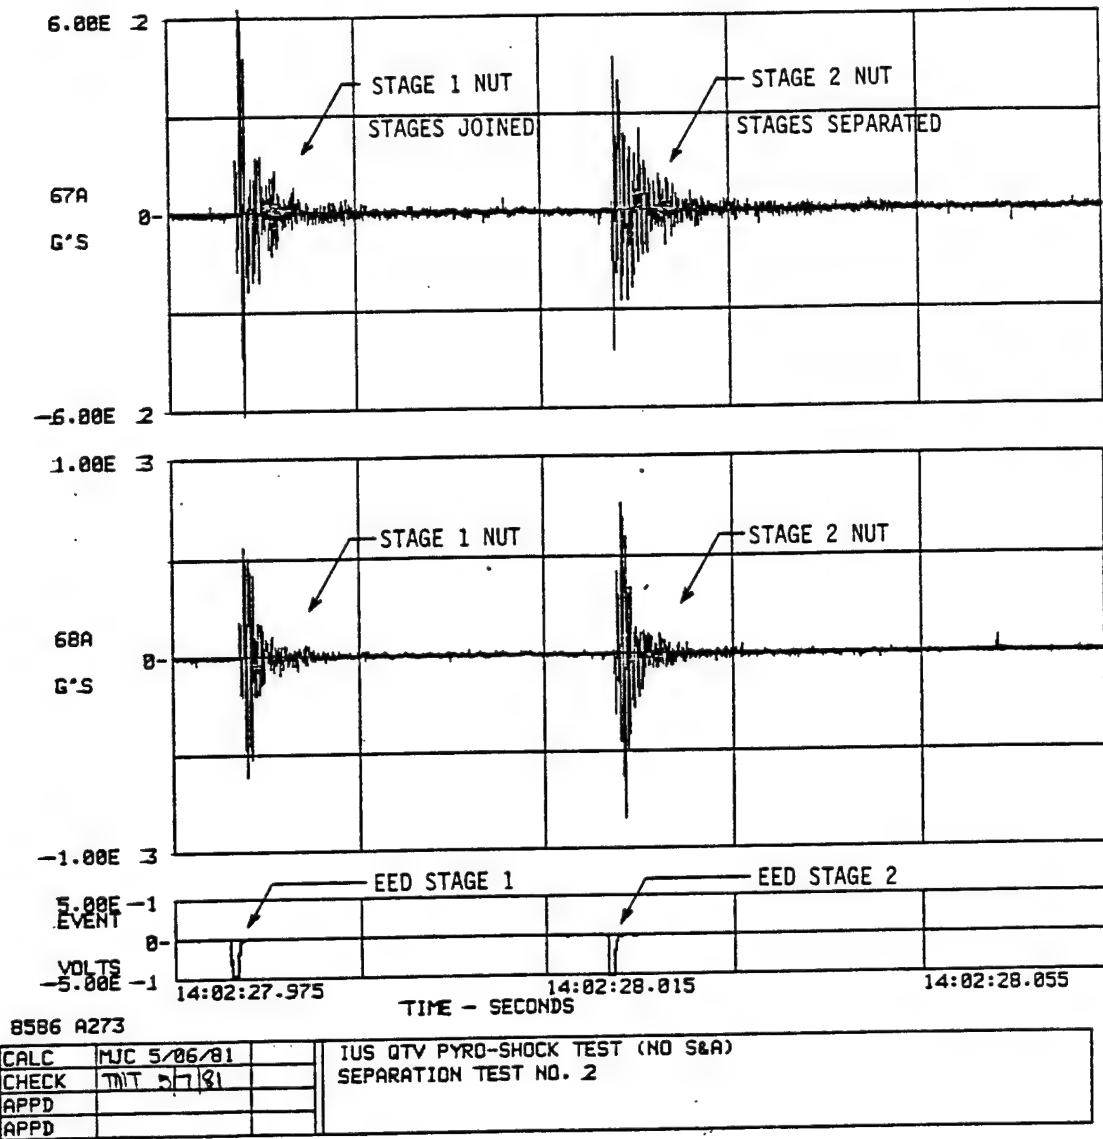
FIGURE 2-3 SHOCK TIME HISTORIES

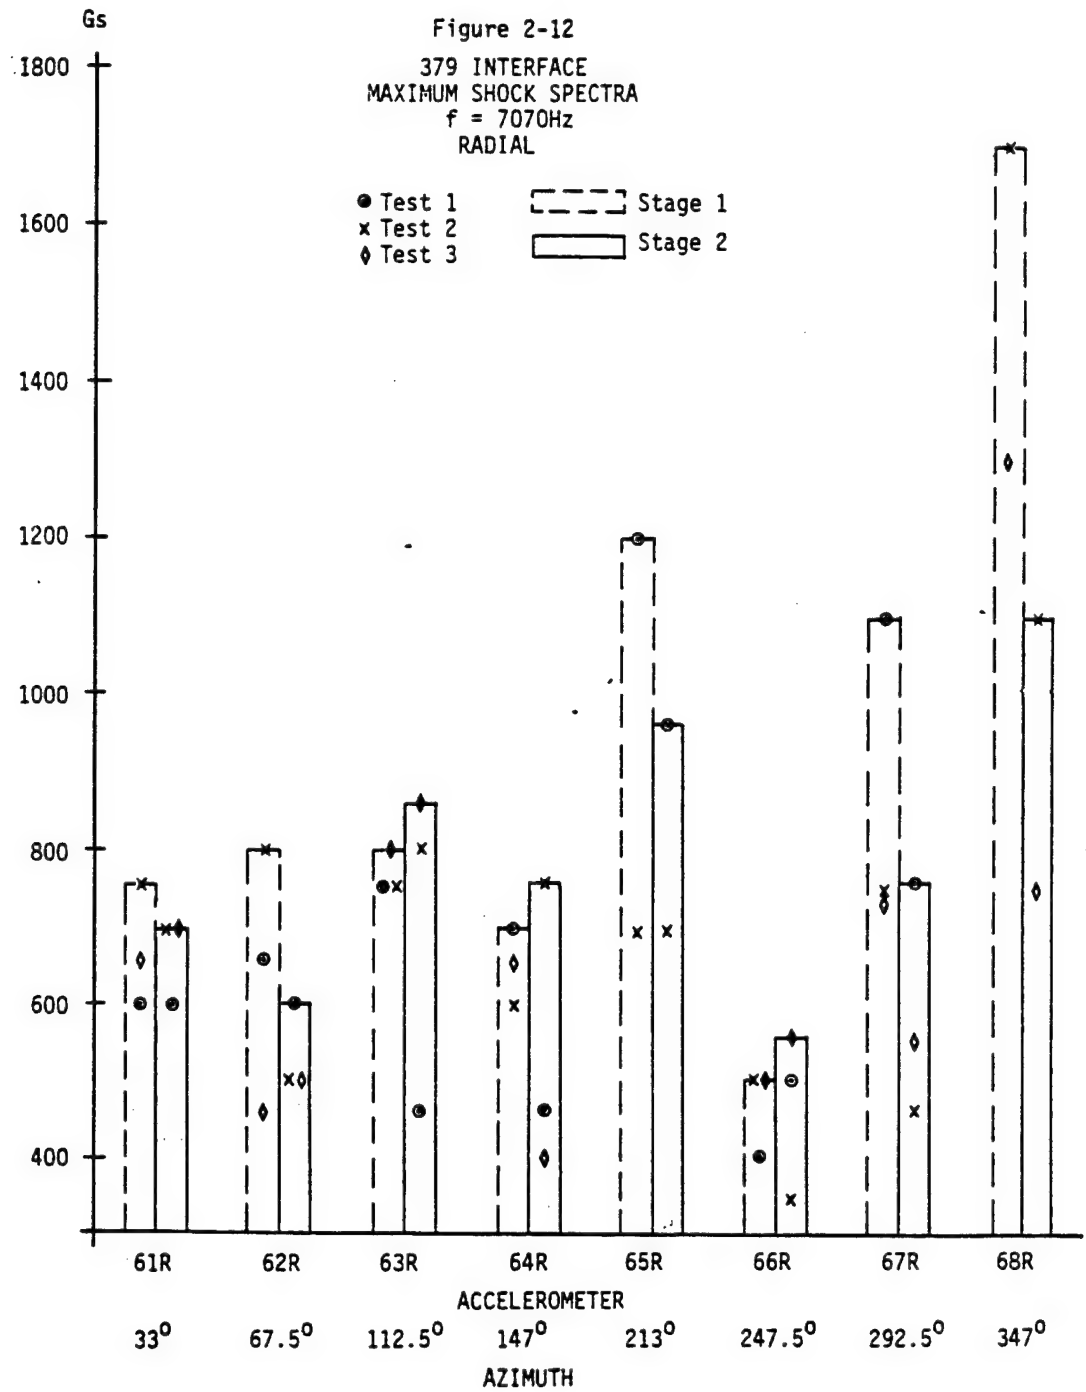
FIGURE 2-13

$K_N = 1.65$ for $N \geq 40$

The P95/50 value was calculated using shock response values in GS read from the shock spectra.

Shock spectra statistics were calculated for selected frequencies where spectral peaks were noted. The calculations are based on the 95%/50% statistics discussed in paragraph 3.19 of MIL-STD-1540A. A tabulation of the statistic calculations and an explanation of the calculation procedure are contained in Figure 2-13.

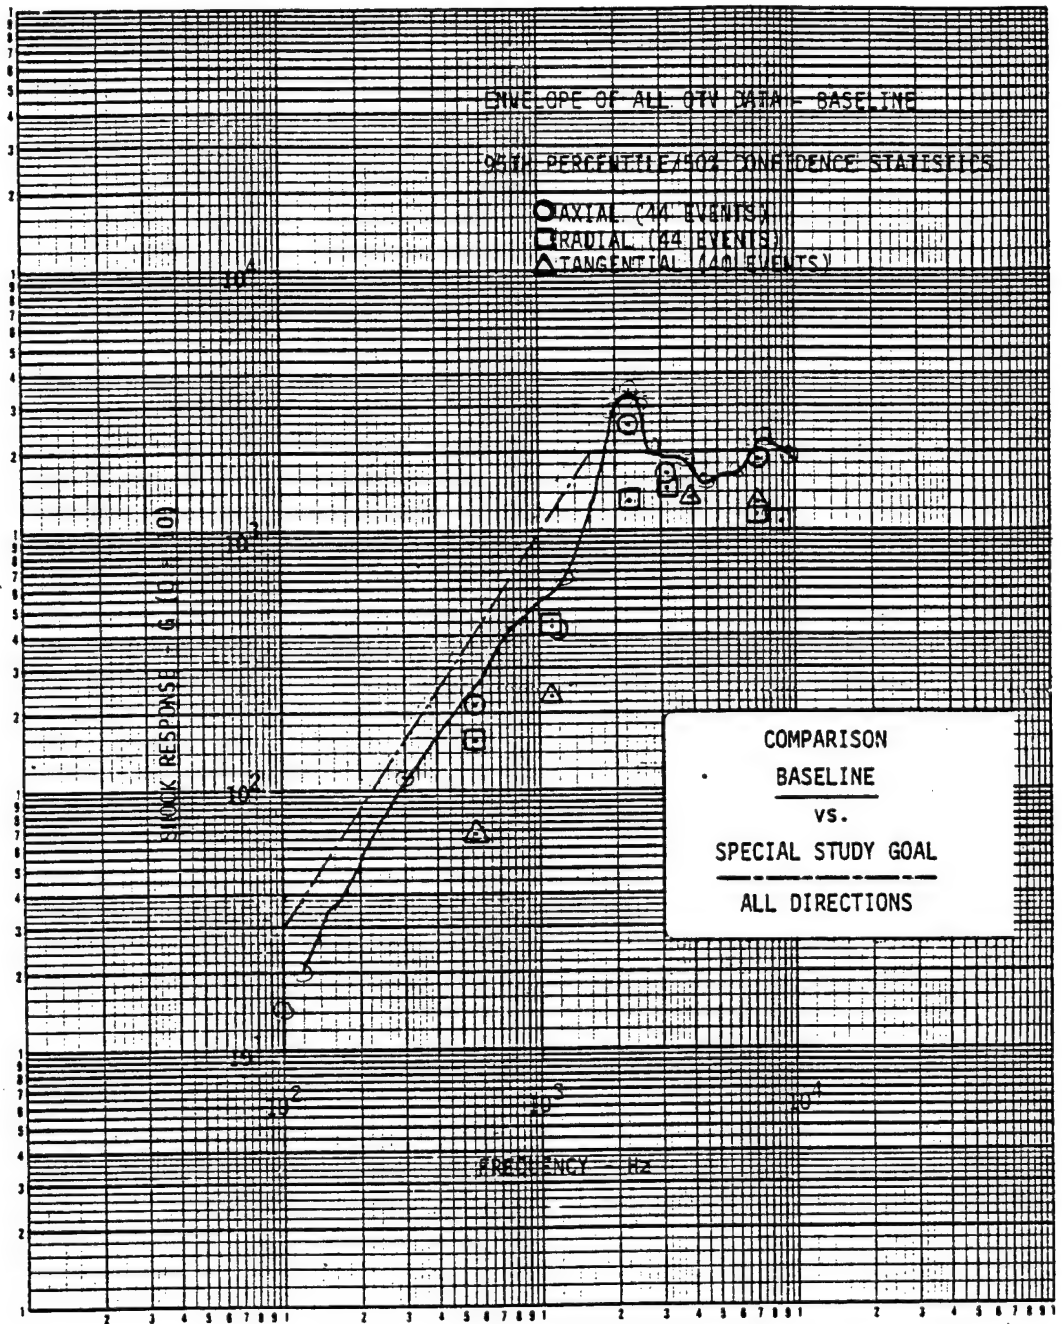
FIGURE 2-14

CALC	<i>C. Beck</i>	9/24/91			IUS INDUCED SHOCK ENVIRONMENT BASELINE IUS/SPACECRAFT INTERFACE	
CHECK						
APPO						
APPO

The Baseline Shock Environment is less than the Special Study Goal except for two frequency ranges, see Figure 2-14. Cost estimates and schedules were not obtained for any of the shock reduction techniques since the Baseline Environment essentially meets the Special Study Goal.

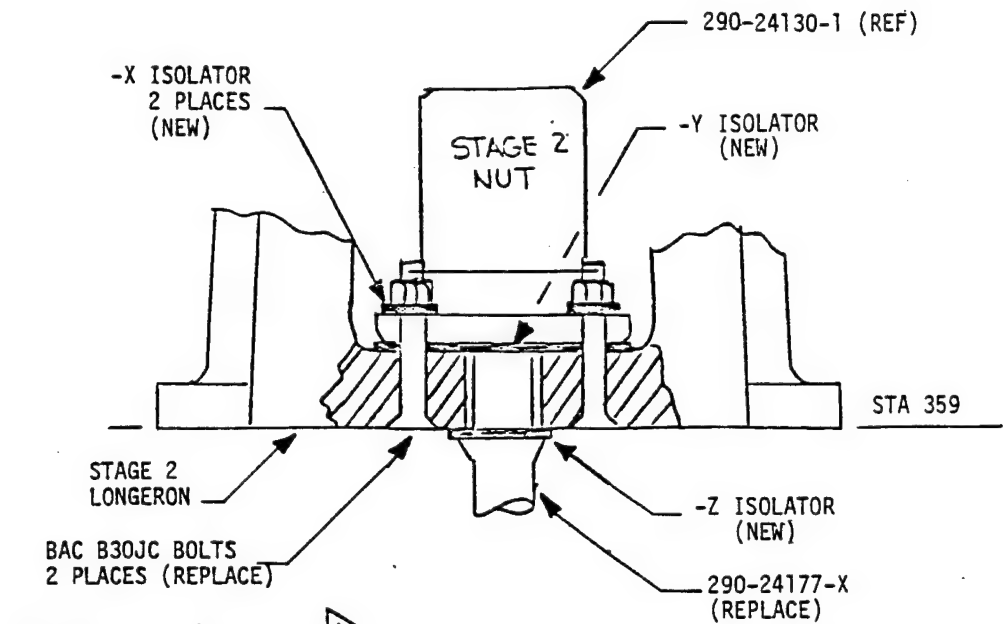
FIGURE 3-3
STAGE 2 NUT ISOLATION DESIGN

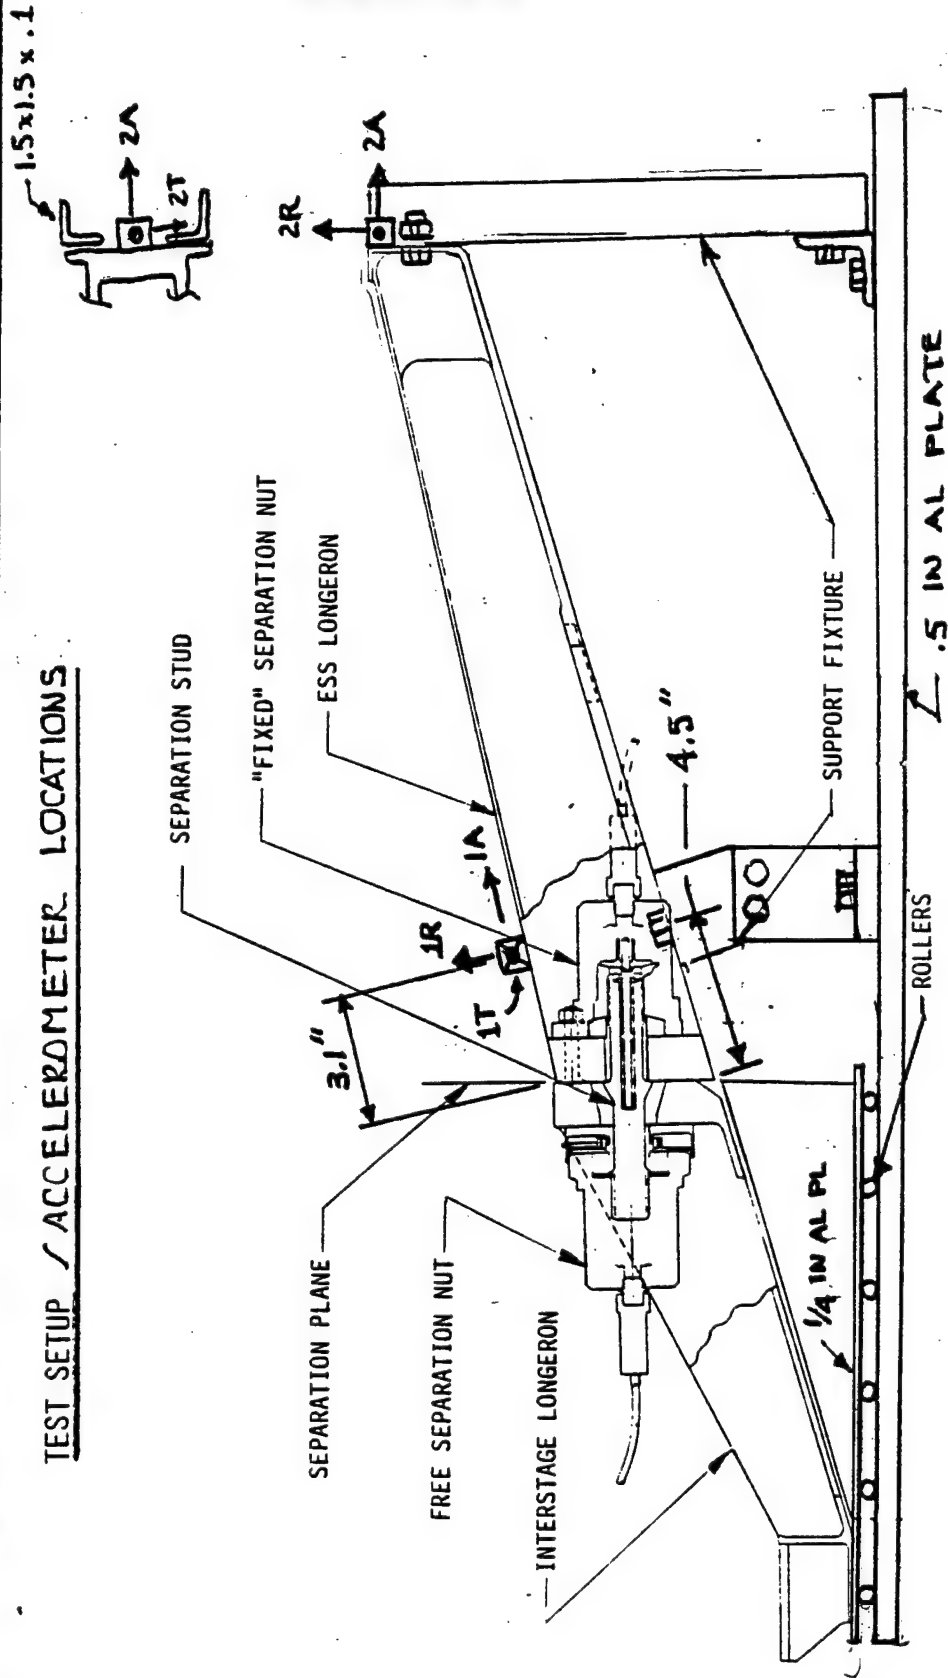
FIGURE 1

TEST SETUP / ACCELEROMETER LOCATIONS

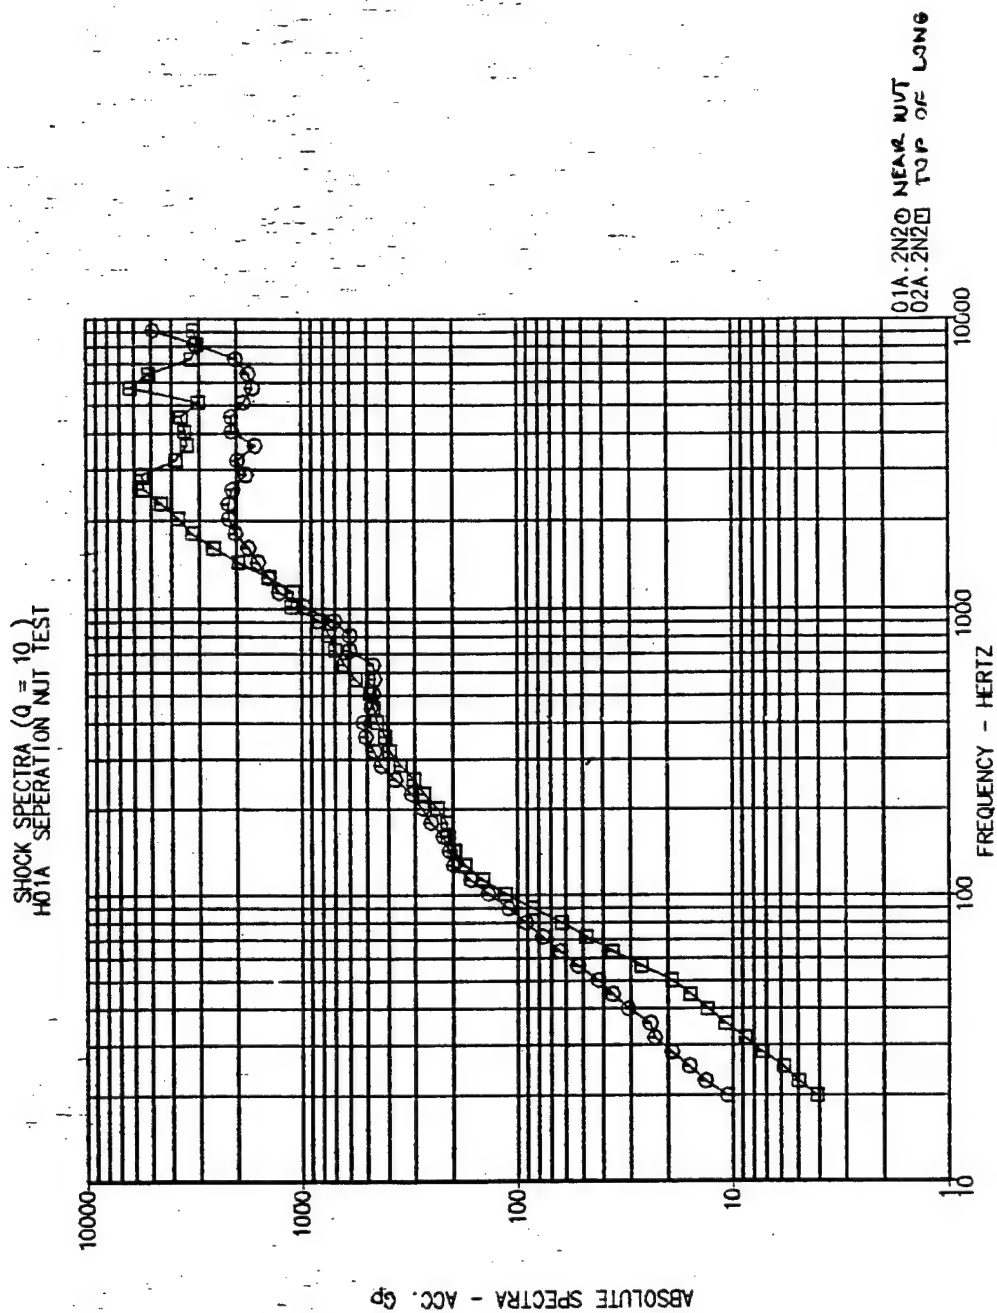
FIGURE 8A ATTENUATION EVALUATION
LOCATION 1 AND 2 AXIAL
2 NUT FIRING

Figures 8, 9 and 10 compare single nut firing spectra near nut and at top of longeron (20 inches from nut). Attenuation is noted above 200 Hz for the radial and tangential directions. However, magnification is apparent in the axial direction. Figures 8A, 9A and 10A show the same comparison for a 2 nut firing.

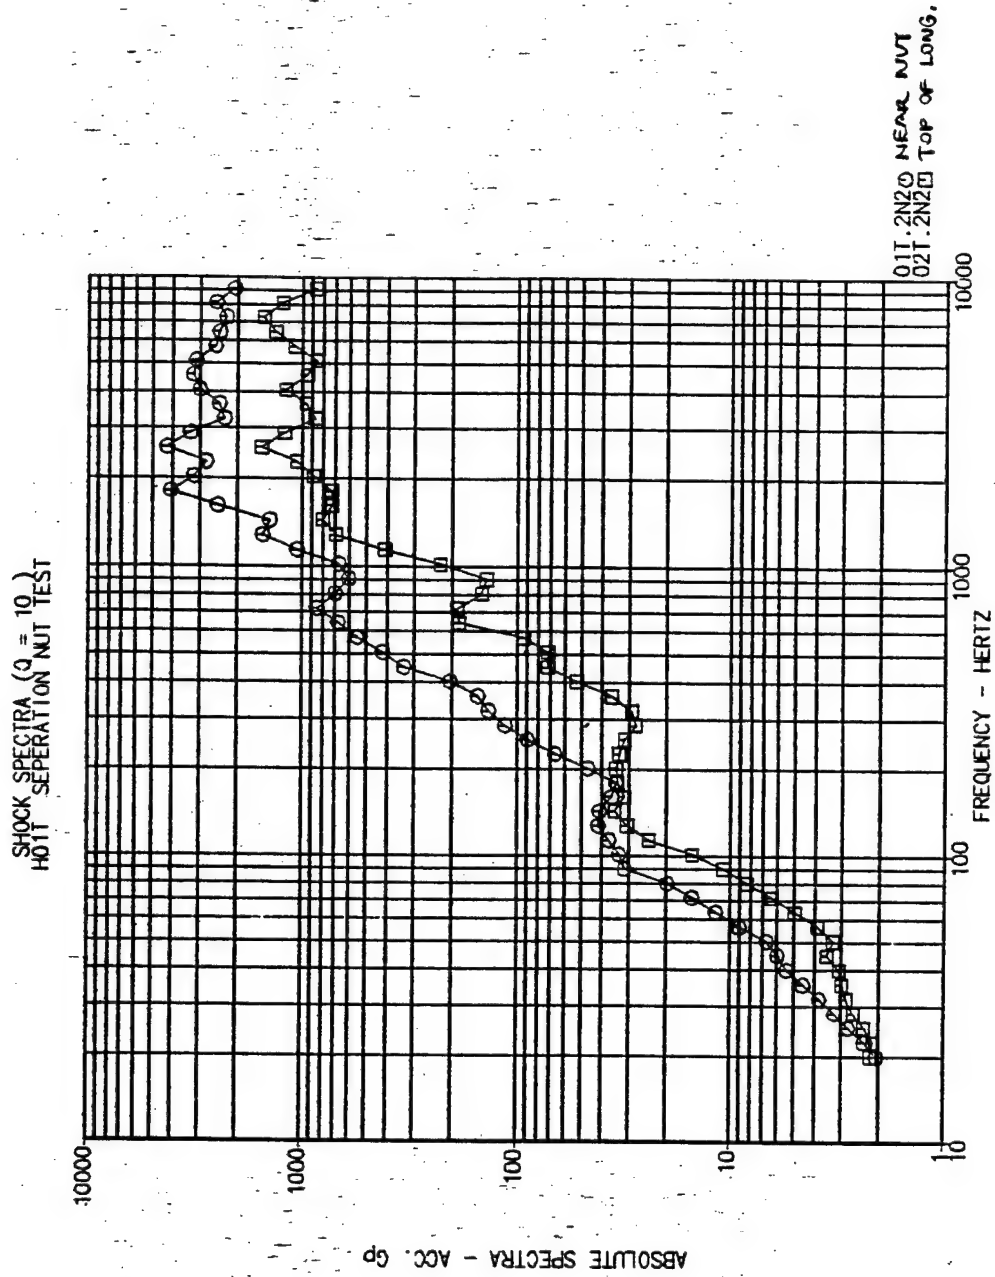
26-JAN-84 07:50:57
FIGURE 10A ATTENUATION EVALUATION
LOCATION 1 AND 2 TANGENTIAL
Z NUT FIRING

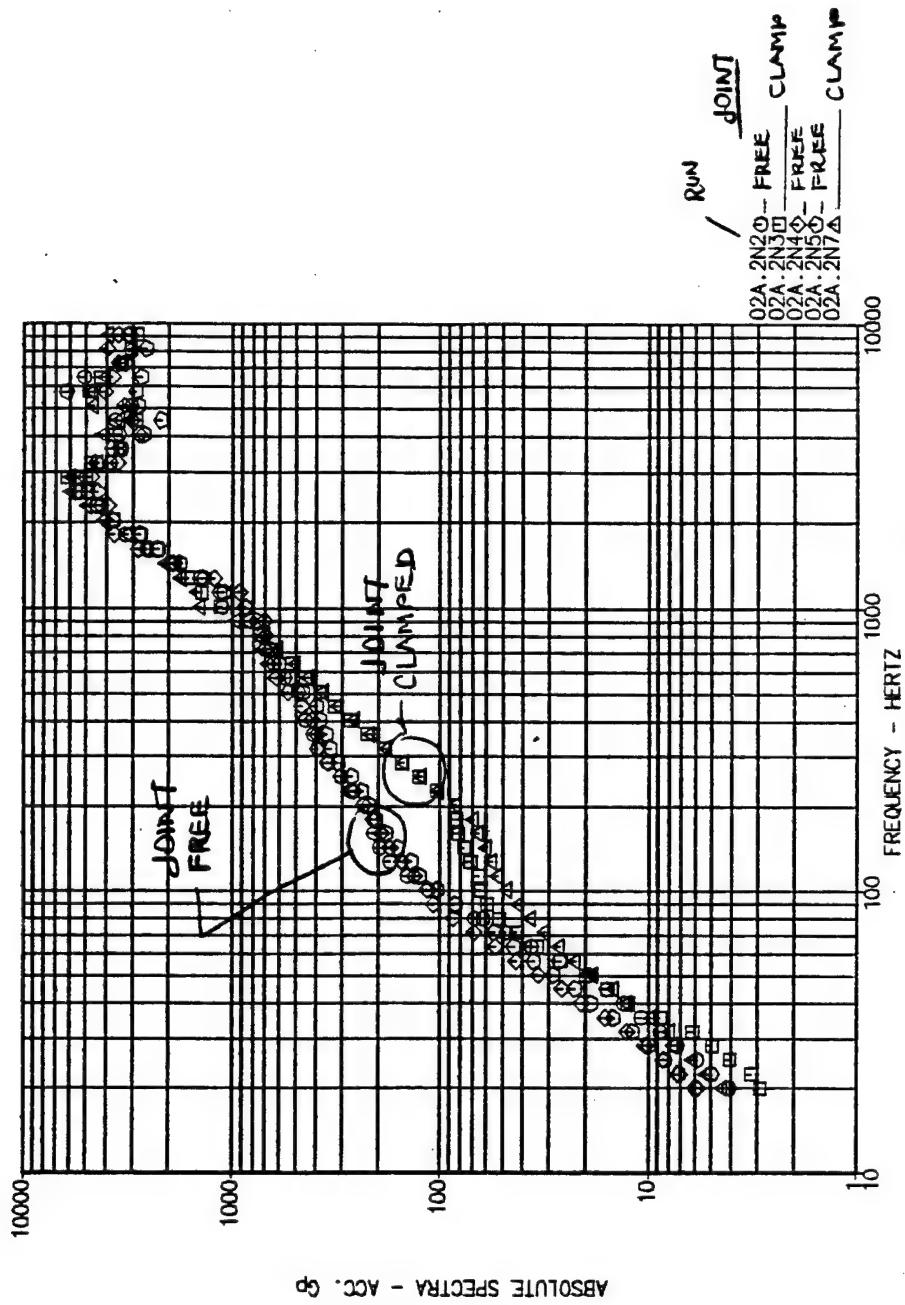
FIGURE 14 2 NUT FIRING
LOCATION 2 AXIAL
JOINT FREE & CLAMPED

Figures 14, 15, and 16 show the shock spectra at location 2 for the 2 nut firing, three directions. Tests were run with the separation joint free and clamped. A significant difference in axial response was noted between clamp and free as shown in Figure 14.

3. The shock response was a function of the nut fired. Differences in the order of 10 dB were noted in the axial direction. The higher levels were caused by the fixed nut. See Figures 23 through 25. Similar differences were observed between the separation joint free and clamped. See Figures 11 and 14.

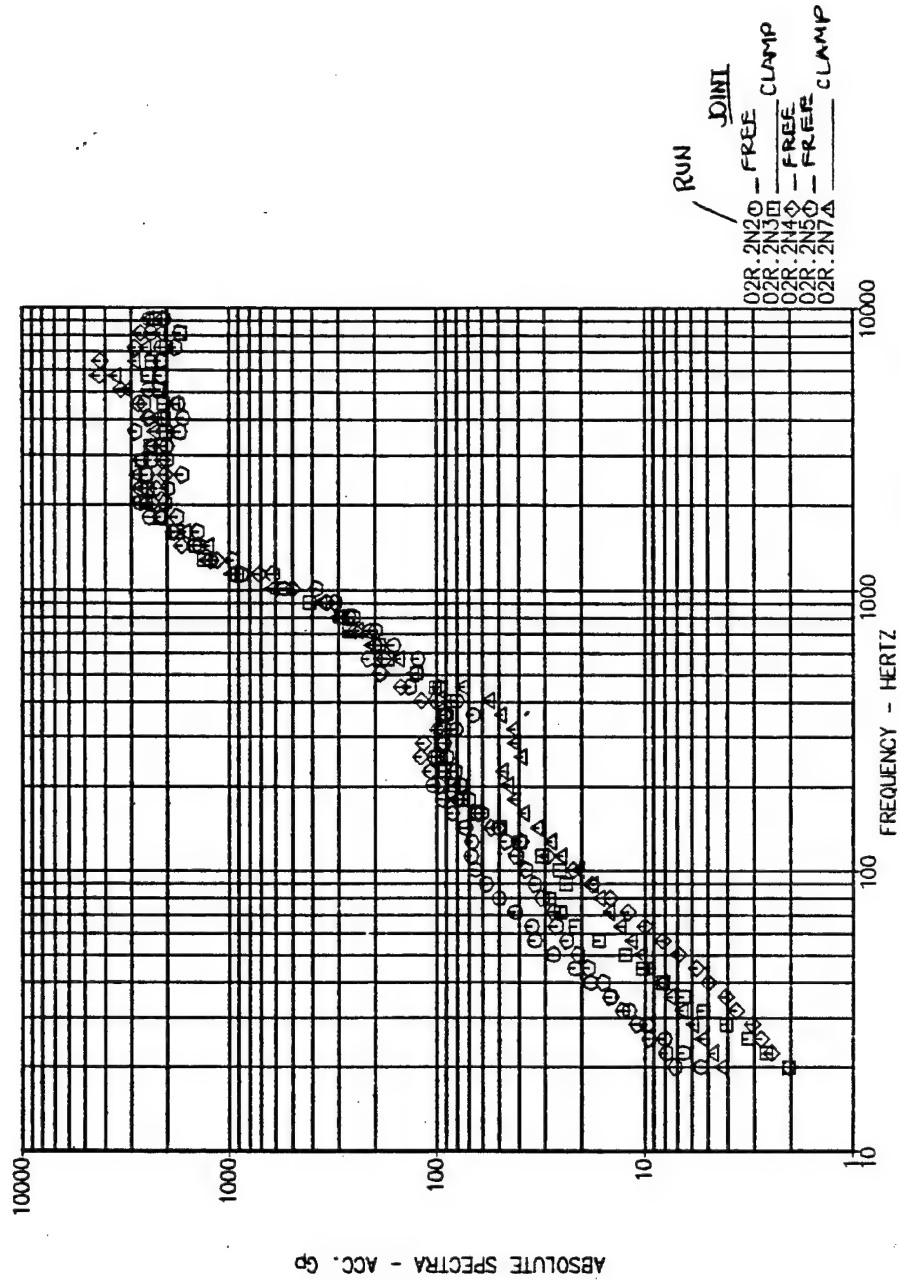
FIGURE 15 Z NUT FIRING
LOCATION Z RADIAL
JOINT FREE & CLAMPED

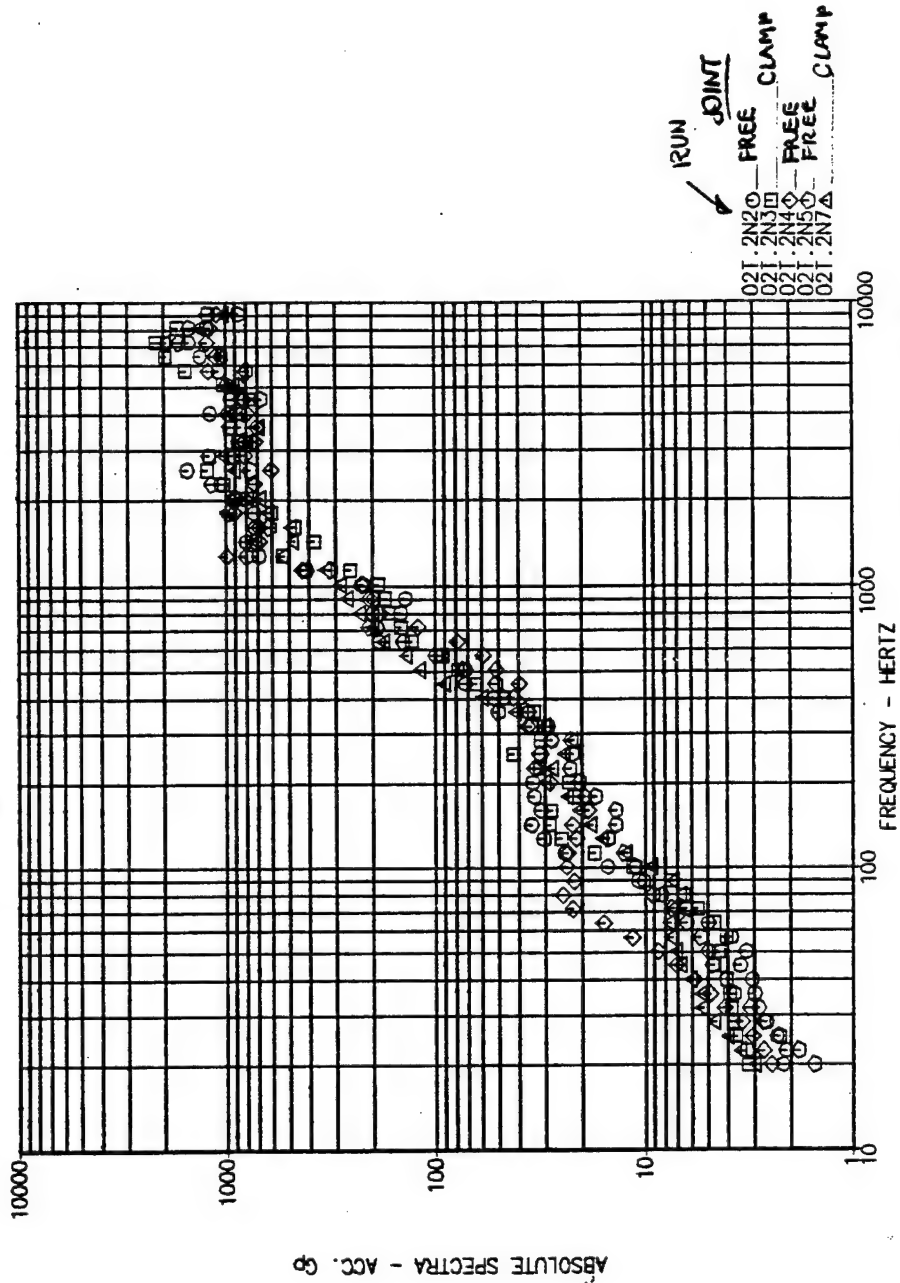
FIGURE 16 2 NUT FIRING
LOCATION 2 TANGENTIAL
JOINT FREE & CLAMPED

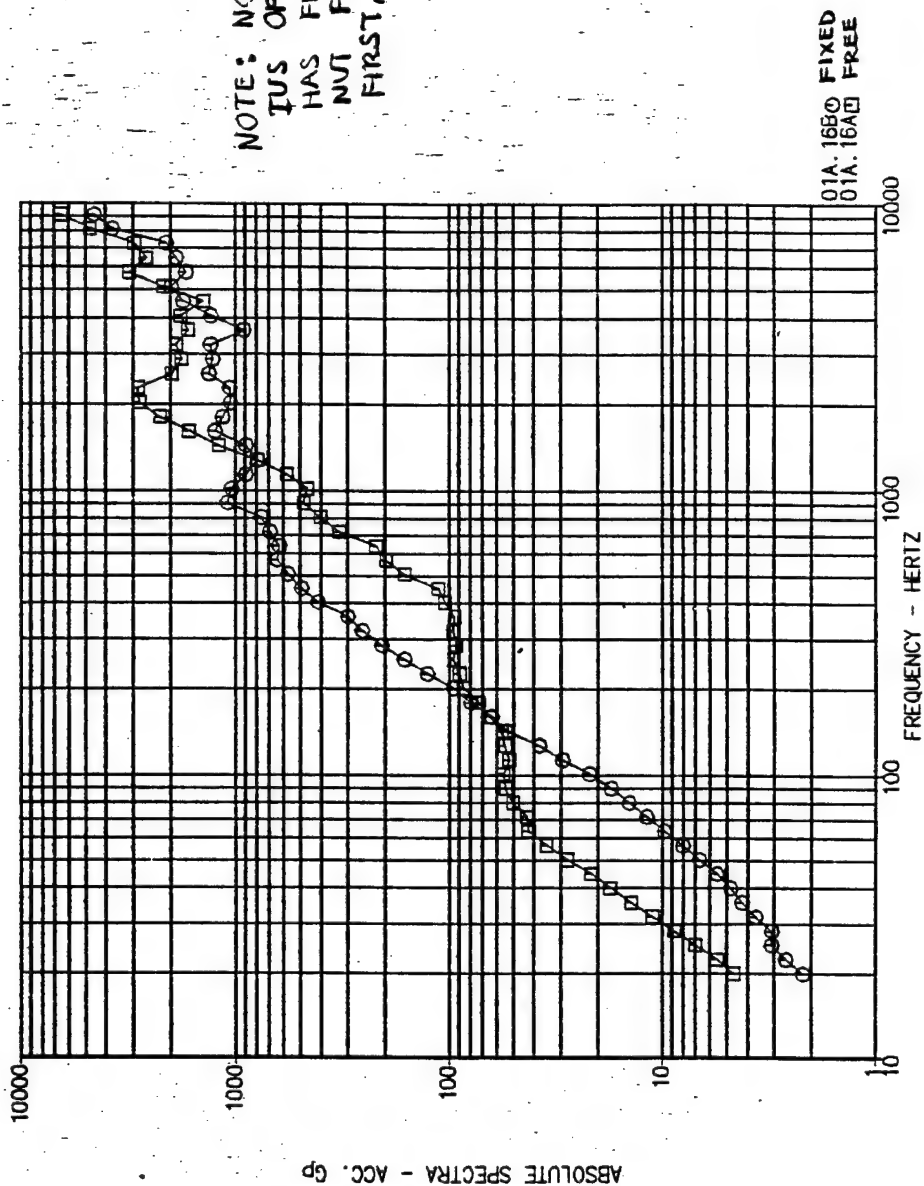
NOTE: NORMAL
TUS OPERATION
HAS FREE
NUT FIRING
FIRST,

FIGURE Z3 SINGLE NUT FIRING
FIXED NUT VS. FREE NUT
LOC. 1. AXIAL

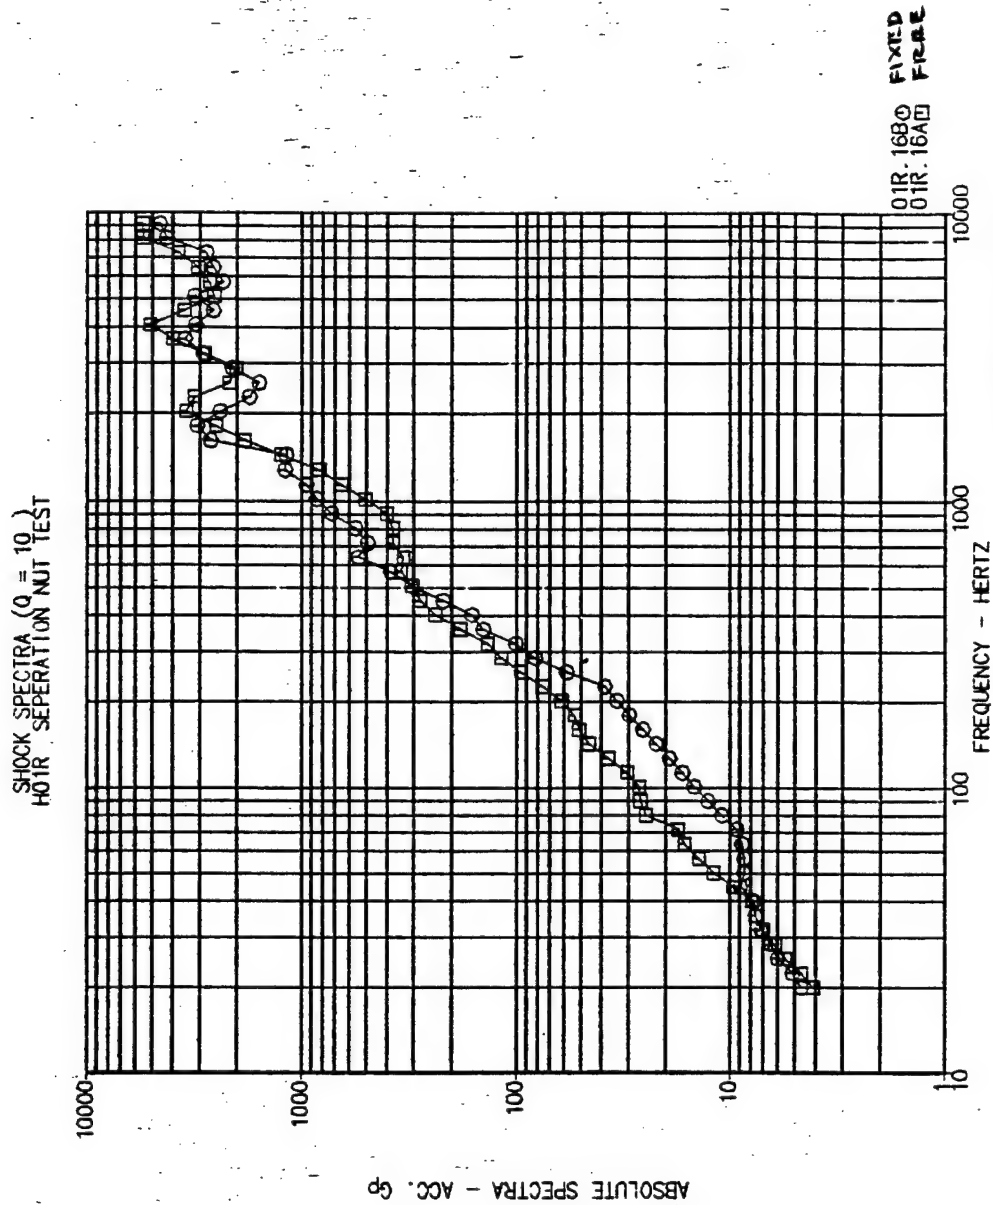
FIGURE Z4 SINGLE NUT FIRING
FIXED NUT VS. FREE NUT
LOC. 1 RADIAL

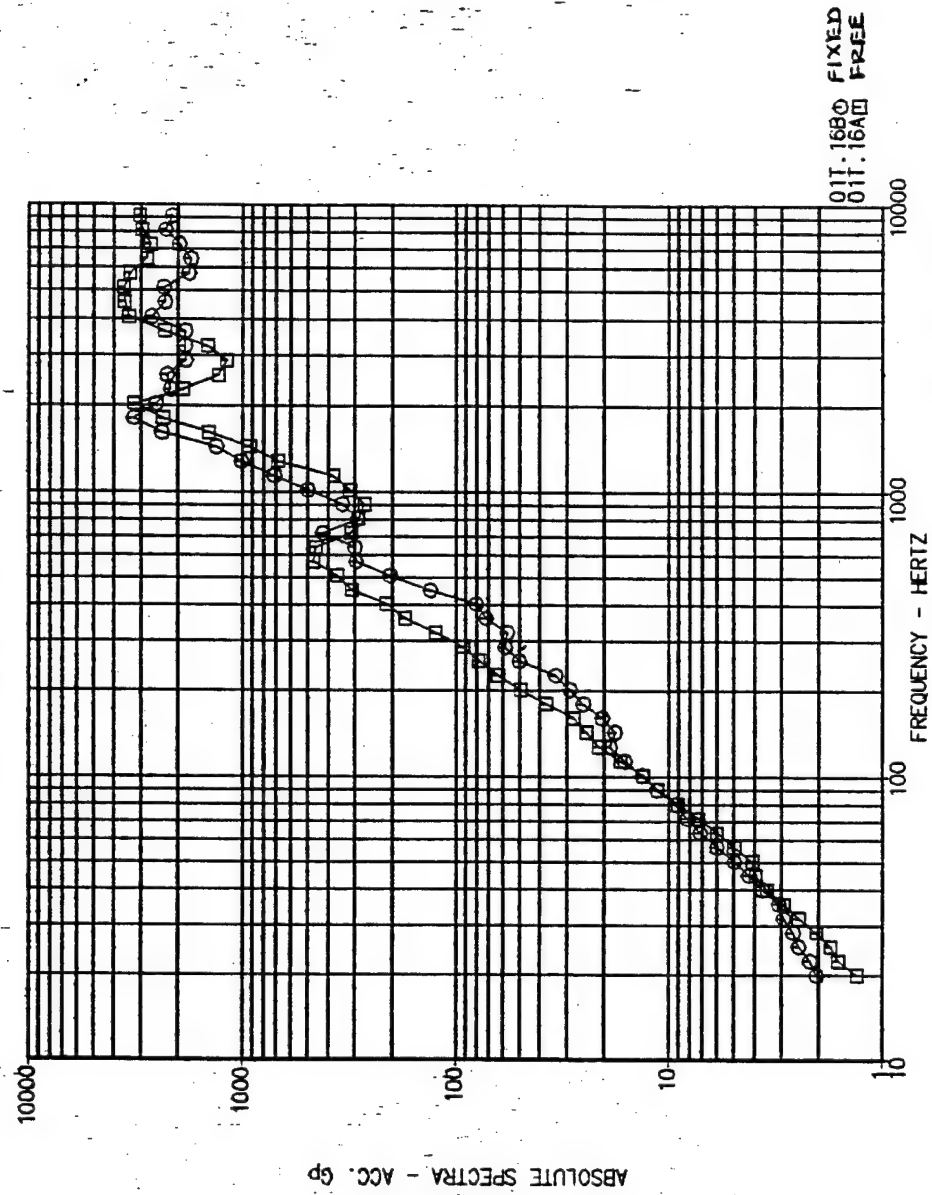
FIGURE 25 SINGLE NUT FIRING
FIXED NUT VS. FREE NUT
LOC. 1. TANGENTIAL

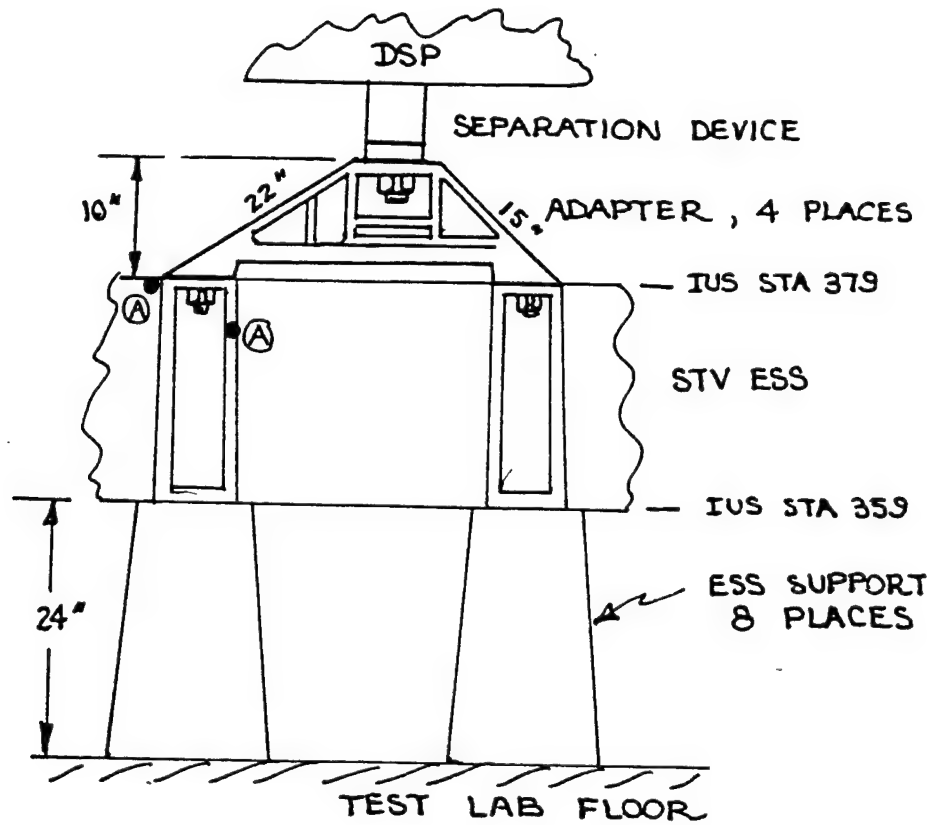
FIGURE 2-1
TEST SETUP

Ⓐ ACCELEROMETERS, SEE FIGURE 2-2

A pyrotechnic shock test of the DSP 14 and IUS Equipment Support Section (ESS) was conducted at TRW in October 1985, reference 1. The pyrotechnic shock was generated when the one inch diameter separation nuts were fired on the DSP. The four separation nuts are located about 10 inches from the DSP/IUS interface plane. The ESS was attached to the test lab floor. The DSP was supported to simulate a zero g condition. The separation test was performed three times. Acceleration response was measured during each of the three tests. The IUS ESS was instrumented with 18 accelerometers.

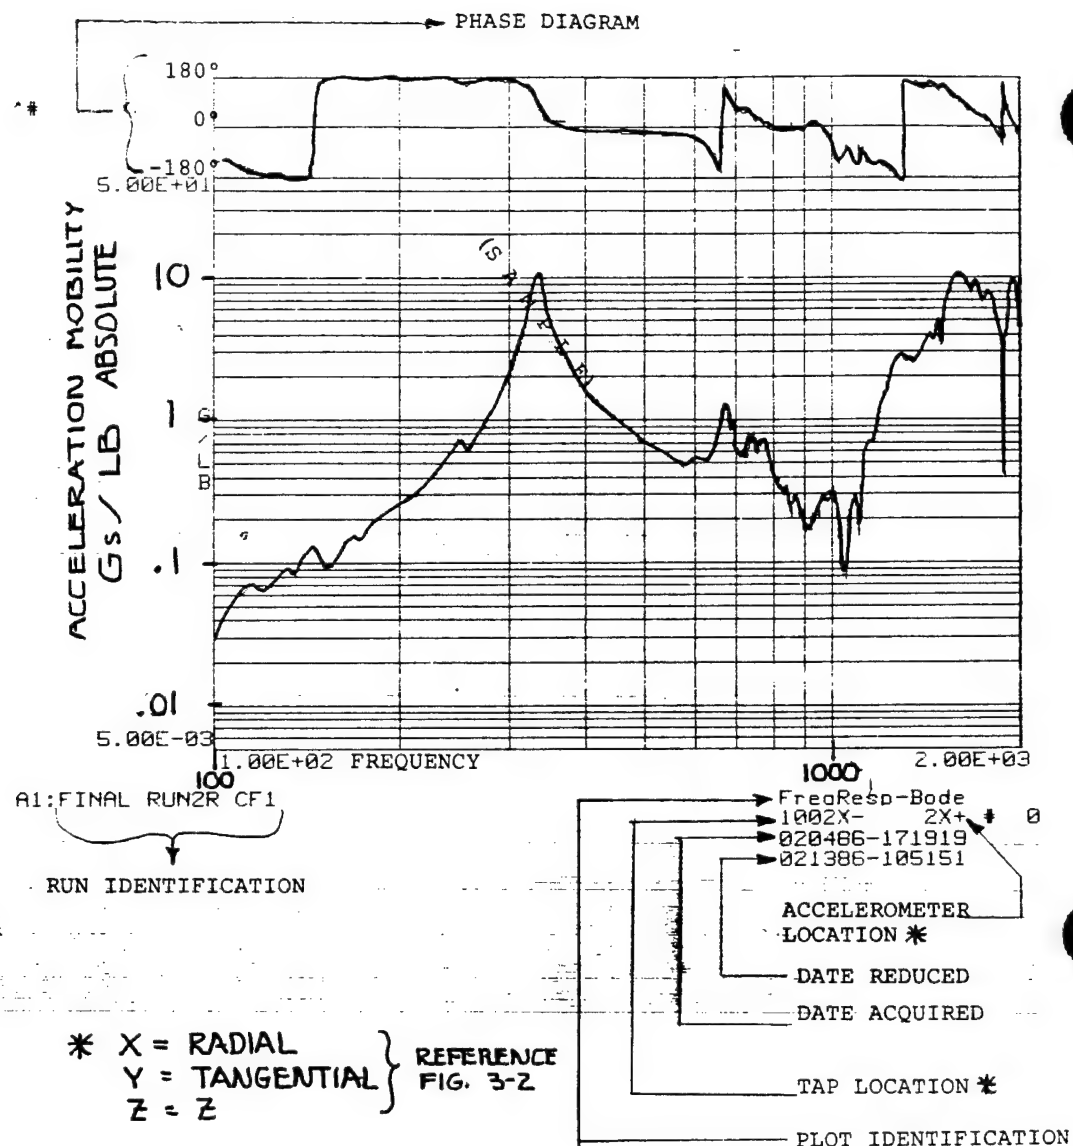
FIGURE 3-3
ACCELERATION MOBILITY GRAPH
